Evolution and Field Performance of a Rescue Robot

Abstract

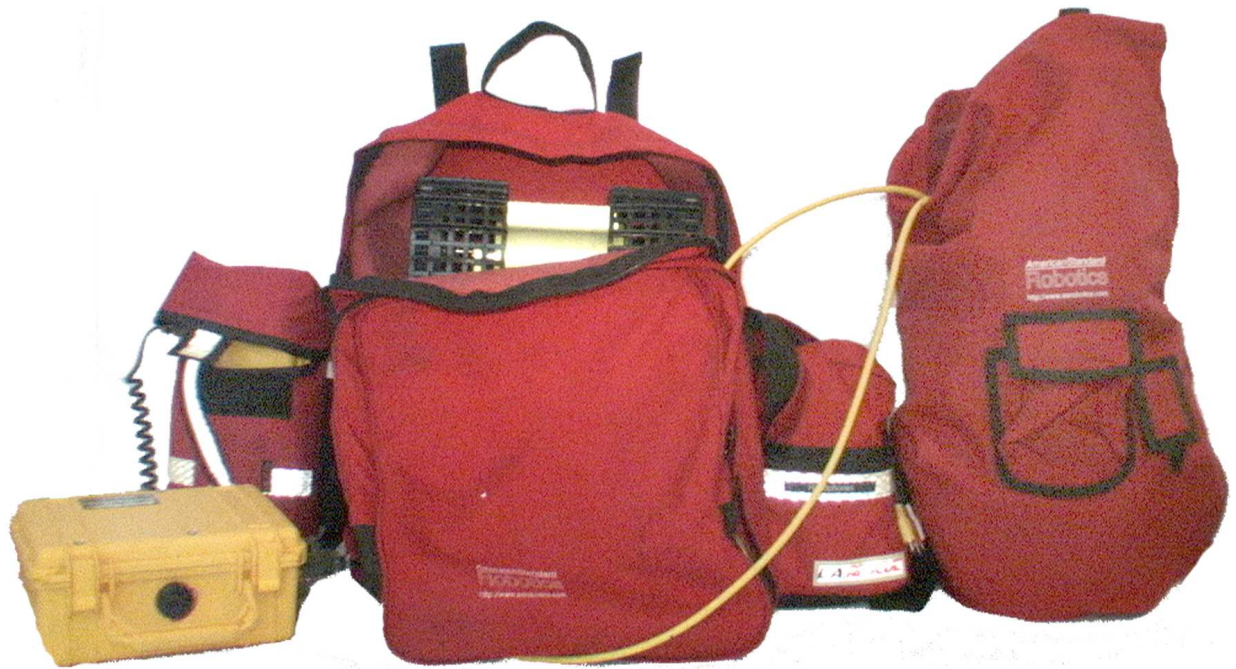
Figure 3: Backpack harness used by the VGTV-Xtreme USAR system. Based on the same harness used by the Federal Emergency Management Agency’s USAR teams, this configuration provides a good balance of portability and deployment time.

The final addition to the VGTV system was a deployment system. The configuration found to be most useful is based on the “LA Rescue Speed Gear” field harness system used by Federal Emergency Management Agency (FEMA) USAR groups. This system uses a central harness from which additional bags are hung. In the robot’s case, a custom bag is made to connect to the back of the harness, creating a standard backpack configuration. This places the bulk of the robot’s weight ergonomically on the operator’s shoulders and upper back. The batteries, operator control unit (OCU), and accessories are then hung from the waist belt. The tether is packed into a rope bag in much the same way as a rappelling rope. This allows the free, unattended flow of tether out of the bag as the robot pulls on it. Finally, this system compliments the gear already used by FEMA search and rescue teams. Therefore, any gear operators were currently using required little reconfiguration. The complete system, including robot, OCU, and harness can be seen in Figure 3.

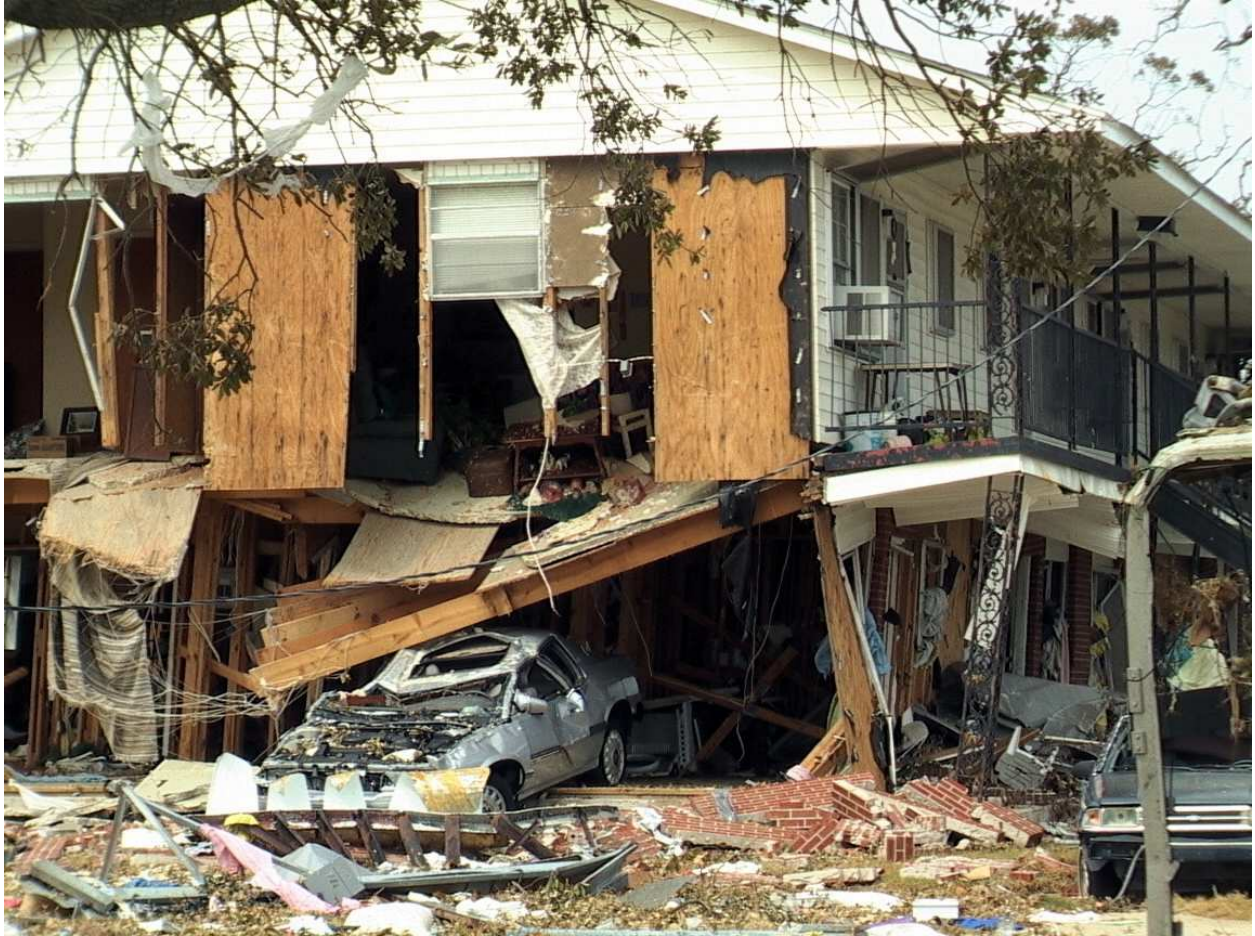
Figure 4: Apartment building damaged by the storm surge, debris, and an automobile during Hurricane Katrina. Notice that the front of the building is structurally compromised and the second floor is partially collapsed. Buildings like this are ideal candidates for robot-assisted search since human search is dangerous at best.

An apartment complex ravaged by the ten-foot storm surge was leaning precariously throughout the first floor levels, shown in Figure 4. Pushed by water and waves, an automobile had crashed through an exterior wall, removing the supporting beams and most of the wall covering. Directly above this gaping hole, the second floor of the building had begun to collapse, and it hung unsupported from the front wall of the structure. Gas leaks and the unstable nature of this structure caused the structural engineers and safety personnel to deem it unsafe for personnel or canine entry earlier in the day. Deceased victims in other areas of the apartment complex caused the command staff to reconsider this decision. The robot was tasked with a preliminary search to determine if shoring should be used to stabilize the building. The shoring would allow human and canine responders to search the structure in relative safety, but required significant time to construct.

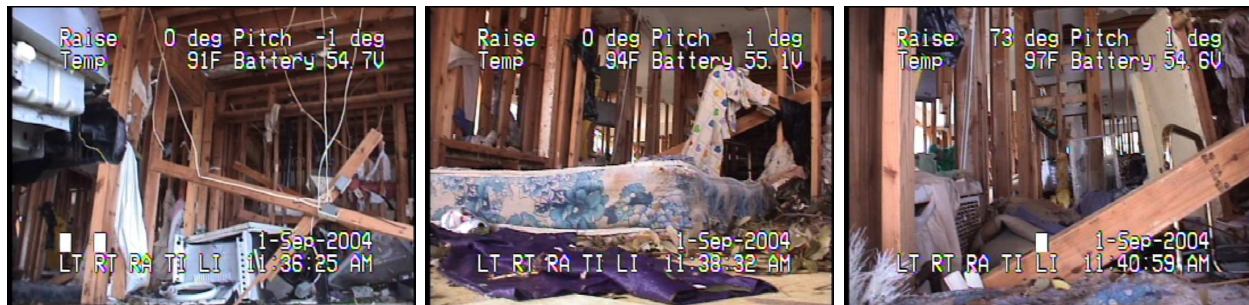
Figure 5: Photos of the VGTV inside the partially collapsed apartment. The view from the insertion point showed that the walls had been destroyed and heavy appliances piled up on the wall studs. (Left) The robot was required to climb up on a mattress (center) to achieve the higher vantage point (left) during this search.

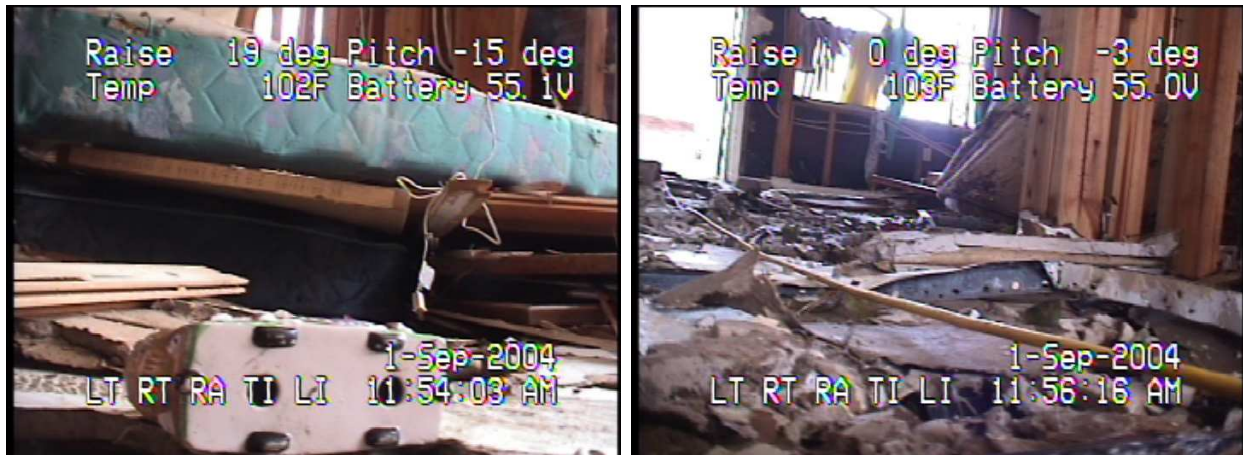
Figure 6: Photos showing the VGTV inside of the apartment. Mattresses and lumber were found piled up at the back door due to storm surge (left). The operator only needed to look behind the robot to see the path out of the apartment provided by the tether (right).
